# International Journal of Research in Engineering and Innovation (IJREI)

#### **REVIEW ARTICLE**

### Breast implant imaging by ultrasound and MRI (Magnetic Resonance imaging)

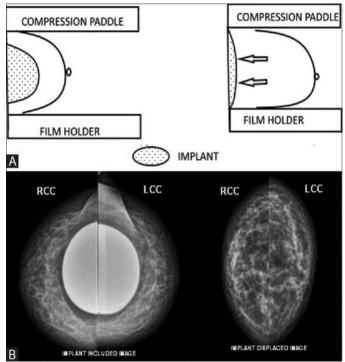
Figure 1: The retropectoral silicone breast implantation is shown schematically also on a mammography. Inside the illustration, one pectoralis muscular covers the implantation. The pectoralis major muscles may be observed posterior to the implants in the right mediolateral oblique (MLO) image.

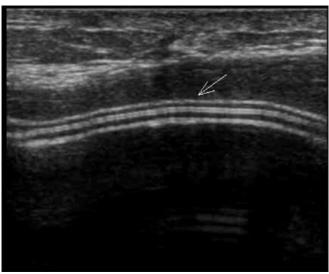
Figure 3: An ellipsoid form of the implantation with an anterior convex form of the anterior or posterior borders of an implantation is seen in this ultrasonography picture (expanded field - of - view) of a lady with an undamaged implantation.
